Pest Inspection Report

88 James Close, Newtown, VIC, 37177

Report/Agreement # 120916023749
Inspection Date: 13 Sep 2016
Inspection Time: 11:30 AM

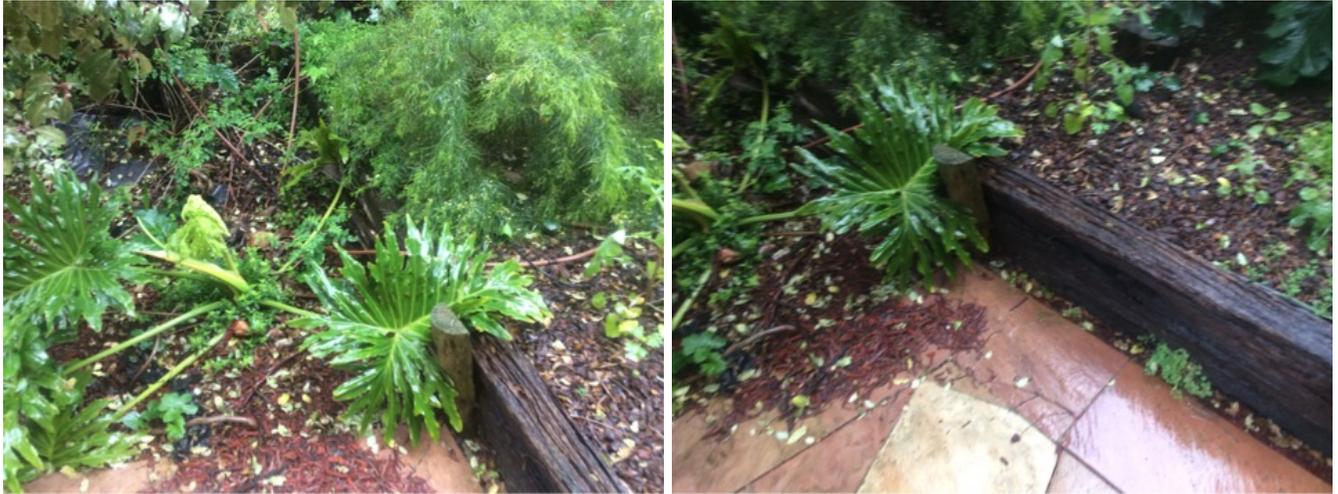
Any Visible Borer of seasoned Timbers Found

Yes - Read this report in its entirety.

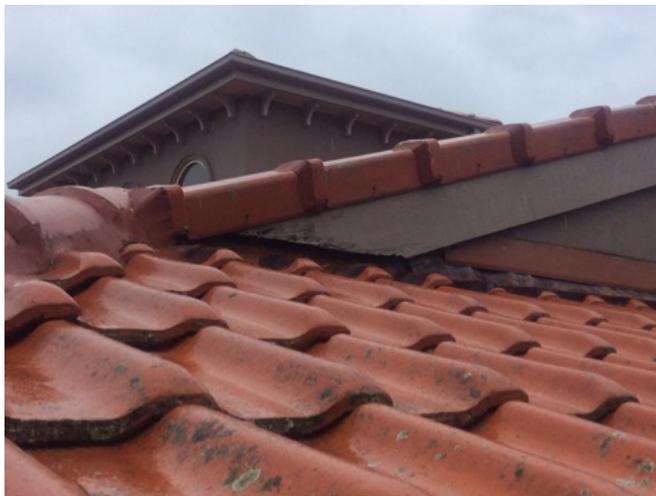
Any Damage caused by Wood Decay, Rot Found

Yes - Read this report in its entirety.

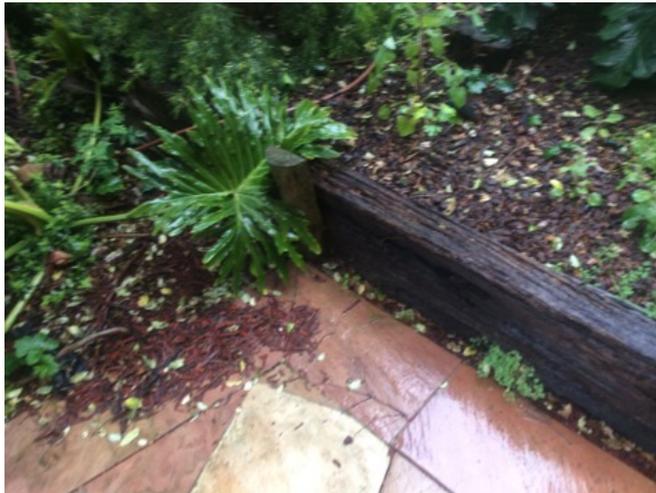
Was Visible Evidence of Borer Found -

Yes, *lyctus brunneus* was found - commonly referred to as the powder post beetle.

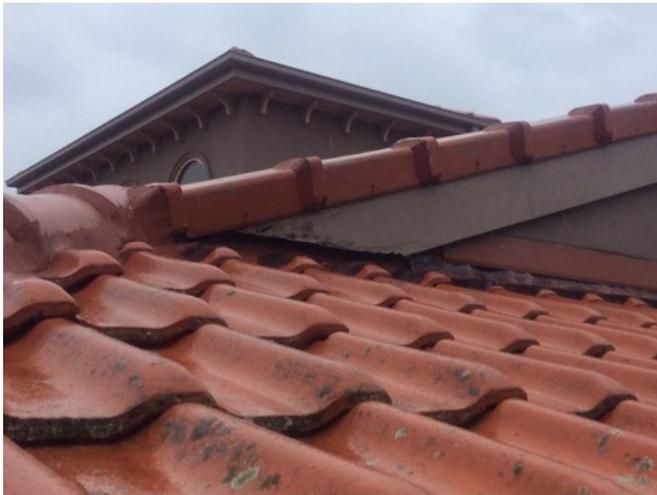
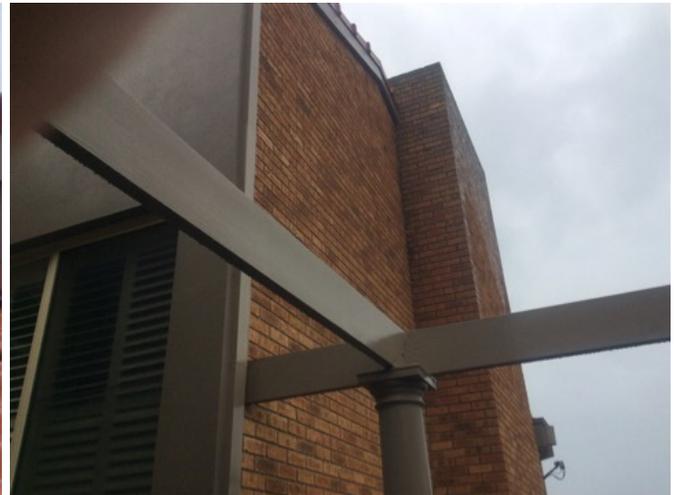
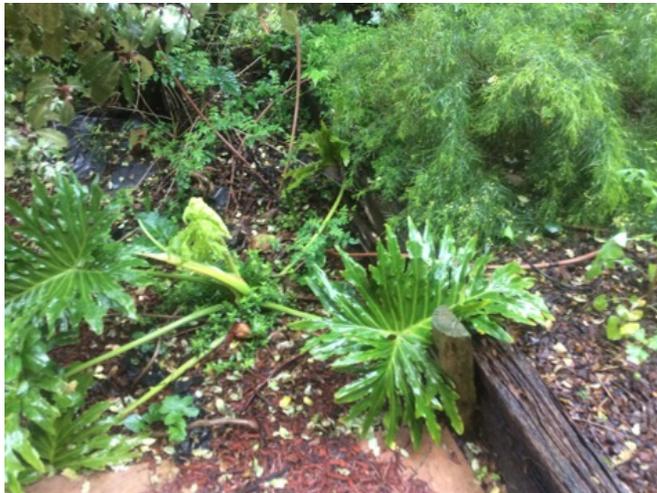
Evidence of Wood Decay Fungi -Rot -

Yes, in the following areas,

Moderate decay damage noted to timbers on the property.

If any evidence of fungal decay or damage is reported you should consult a building expert to determine the full extent of damage and the estimated cost of repairs or timber replacement (see terms & limitations).

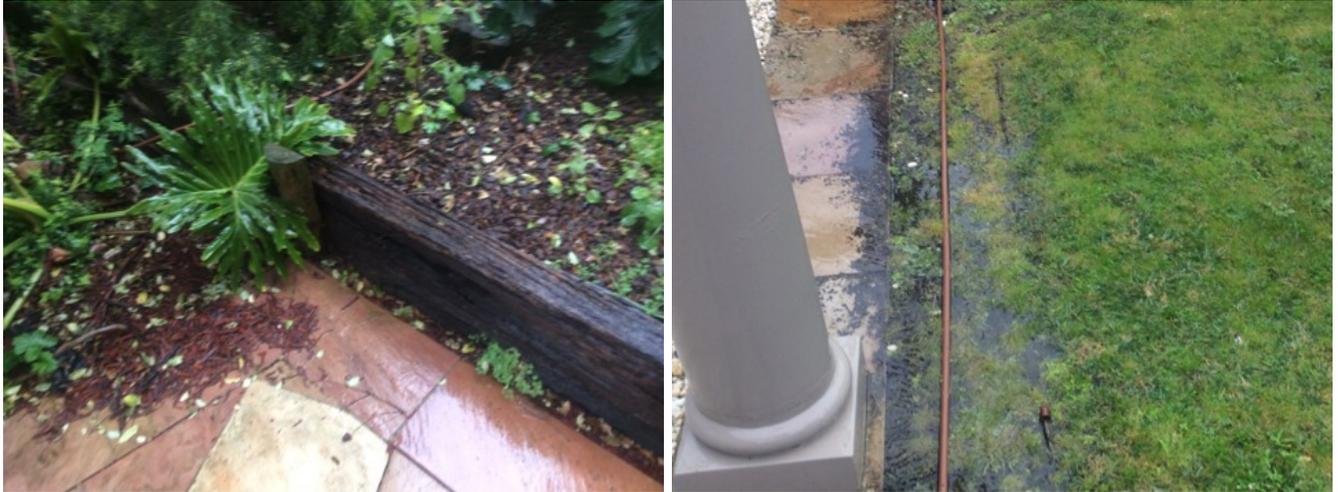
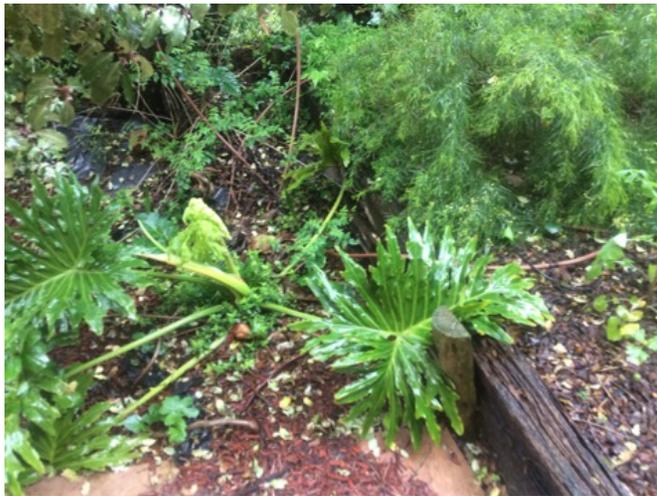
There are timber sleepers in the garden. Termites love nesting below timber sleepers as it provides a good food source while also providing protection for the nest. It is recommended that all timber sleepers be removed or replaced with a non-susceptible product (i.E. Concrete).

Excessive surface water drainage can create conditions conducive to termite infestation.
